INSPECTION *report*

46-369 Haiku Road , Suite H17
Kaneohe, HI

Wednesday, January 25, 2017

Report No. 1018, v.2

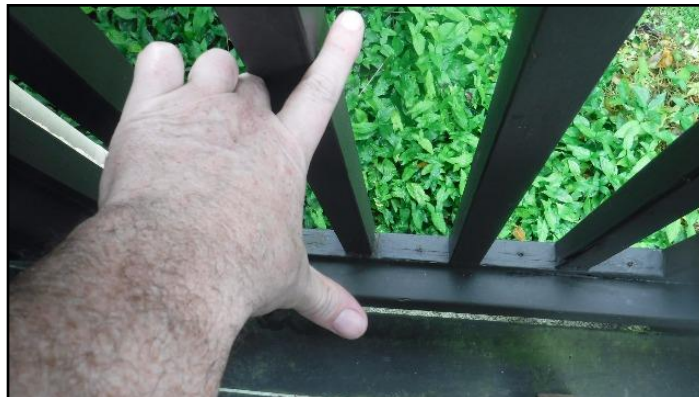
3. Condition: • [Loose](#)

Spindle is loose

Implication(s): Fall hazard

1. Loose

Task: Repair

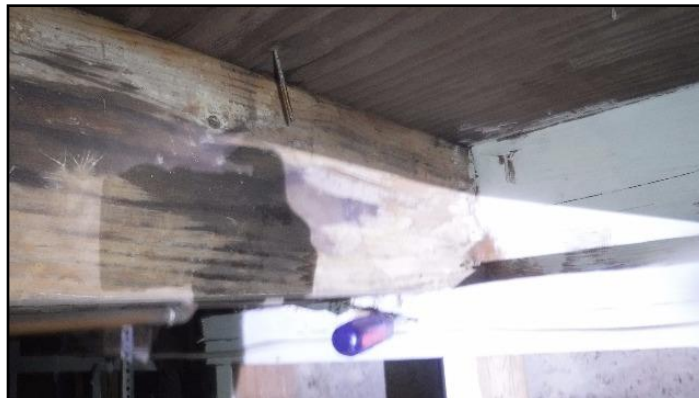
4. Condition: • [Rot or insect damage](#)

This appears to be very localized damage.

Implication(s): Weakened structure | Chance of structural movement

Location: Crawl Space Utility Room

2. Rot or insect damage

Task: Monitor

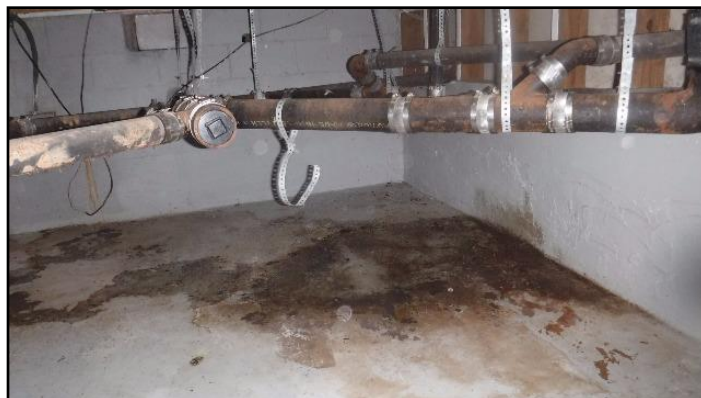
7. **Condition:** • [Leak](#)

This appears to be sewage given the smell in the room. Recommend consult with a plumber to repair.

Implication(s): Sewage entering the building

Location: Crawl Space

5. Leak

Task: Repair Further evaluation

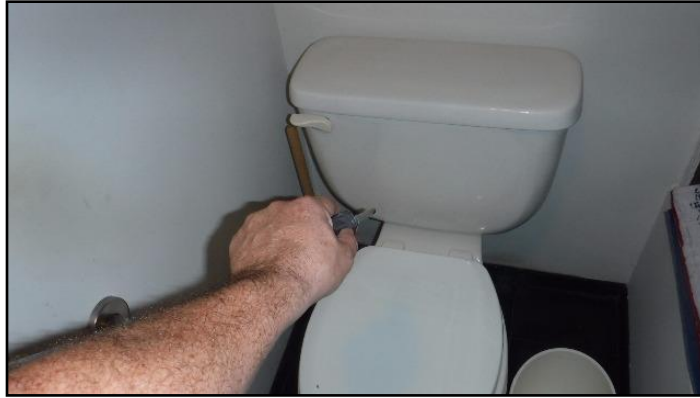
8. Condition: • [Flush mechanism inoperative](#)

Upstairs, master bathroom toilet not operated.

Implication(s): Equipment failure | Sewage entering the building

6. *Flush mechanism inoperative*

Task: Further evaluation

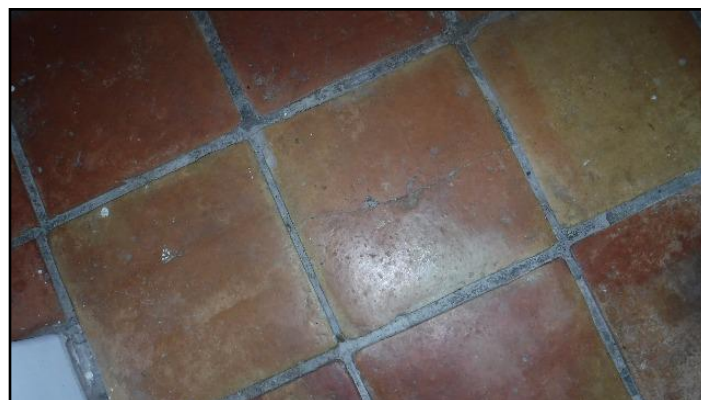
9. Condition: • [Grout missing](#)

Implication(s): Cosmetic defects | Trip or fall hazard

7. Grout missing

Task: Repair

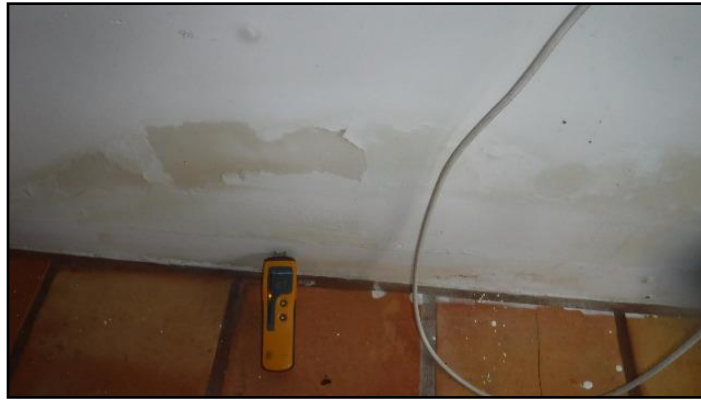
10. Condition: • High moisture reading

Downstairs bedroom wall tested higher for moisture than is typical. This is most likely due to no ventilation for some time. Continue to monitor.

8. High moisture reading

Task: Monitor

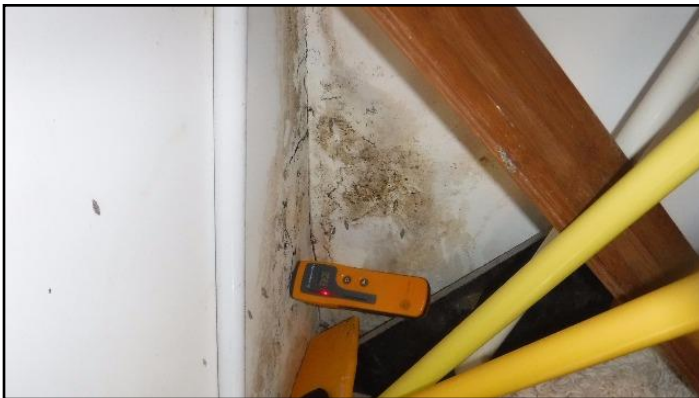
11. Condition: • [Water damage](#)

Mold and high moisture level detected on this closet wall. Toilet sits directly behind this wall.

Implication(s): Cosmetic defects

9. Water damage

Task: Repair Further evaluation

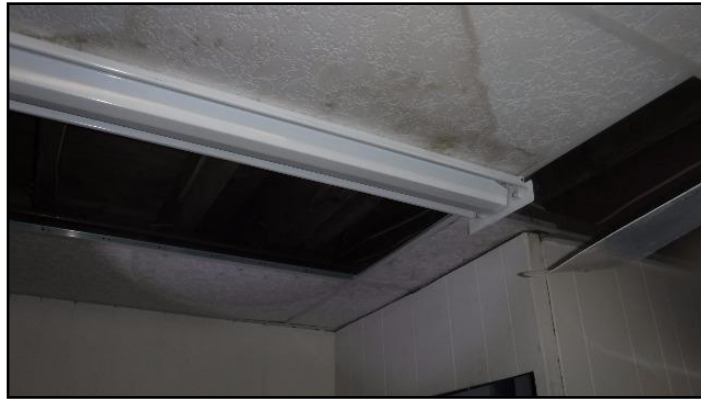
12. Condition: • Stains

Seller can be consulted as to history of water stains on ceiling in basement. Area tested dry at time of inspection.

Implication(s): Cosmetic defects

11. Stains

Task: Monitor

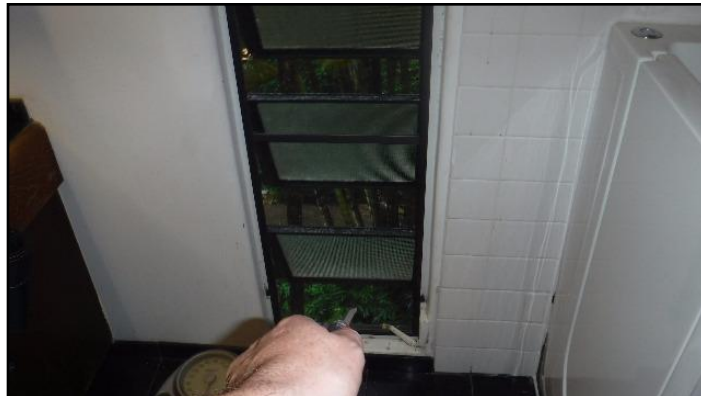
13. Condition: • Inoperable

Jalousies in both bathrooms did not function (open or close).

Implication(s): System inoperative or difficult to operate | Reduced comfort | Restricted emergency exits

Location: Bathroom Master Bathroom

12. Inoperable

Task: Repair

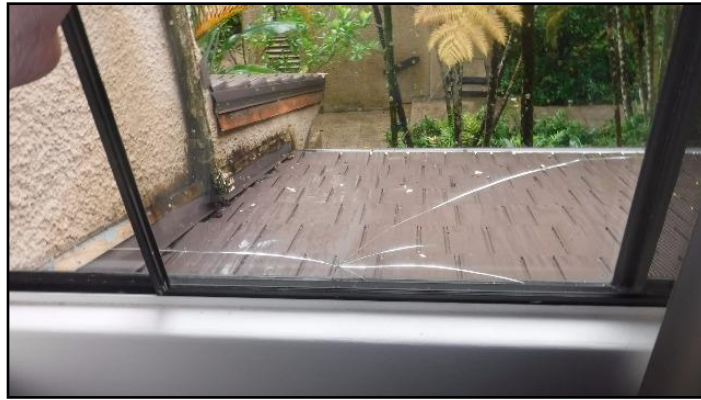
14. Condition: • [Broken](#)

Implication(s): Cosmetic defects | Chance of water entering building | Physical injury | Increased heating and cooling costs | Reduced comfort

Location: Master Bedroom

13. Broken

Task: Repair

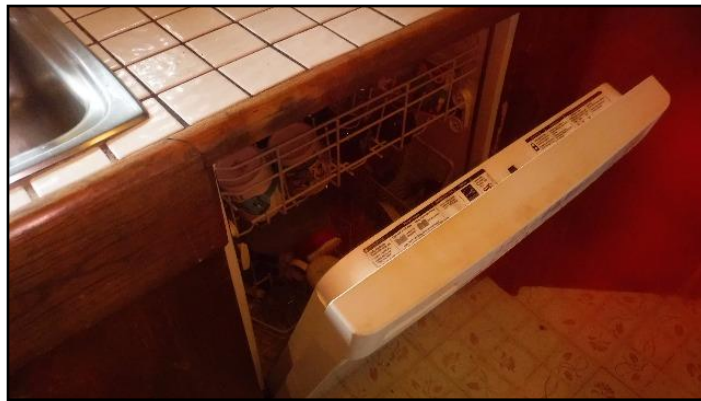
15. Condition: • Inoperative

No water observed to flow while dishwasher operated.

Implication(s): Equipment inoperative

14. Inoperative

Task: Repair

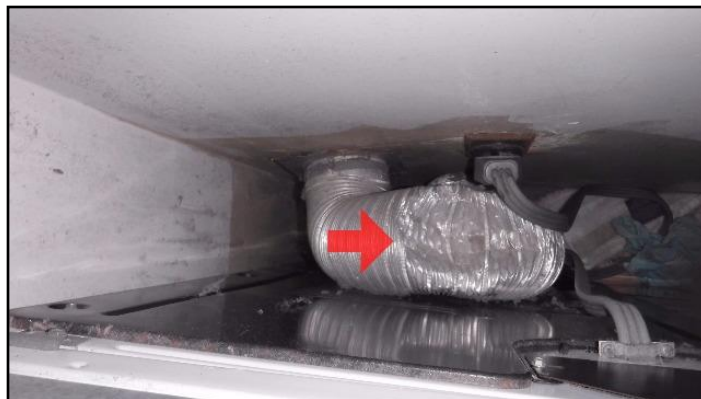
16. Condition: • Dryer vent obstructed

Implication(s): Equipment ineffective | Fire hazard

15. Dryer vent obstructed

Task: Repair
