INSPECTION *report*

1234 Clover Lane
Boise, ID 83642

INSPECTION DATE:
Friday, September 25, 2020

RE: Report No. 1039
1234 Clover Lane
Boise, ID
83642

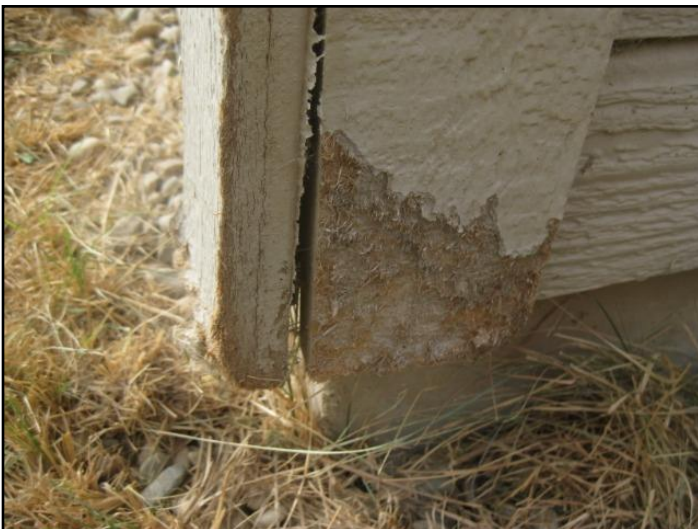
Some minor trim surface damage or gaps in joints was observed. Improving these areas should be relatively simple.

11. Surface damage

Task: Improve Monitor

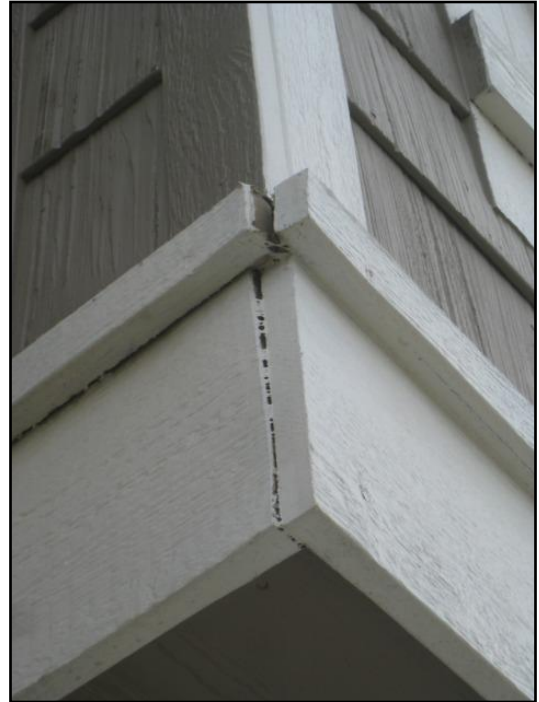
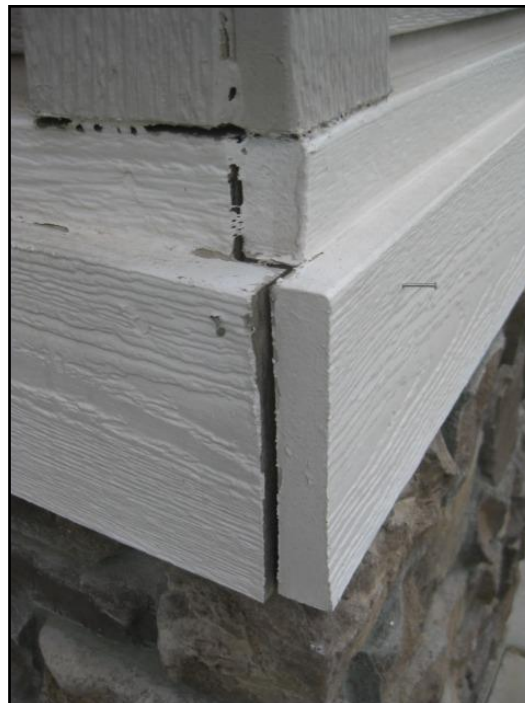
12. Loose

13. Loose

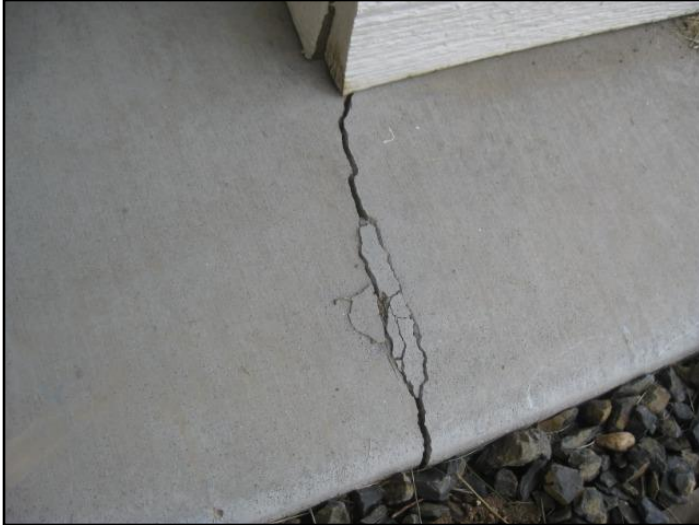
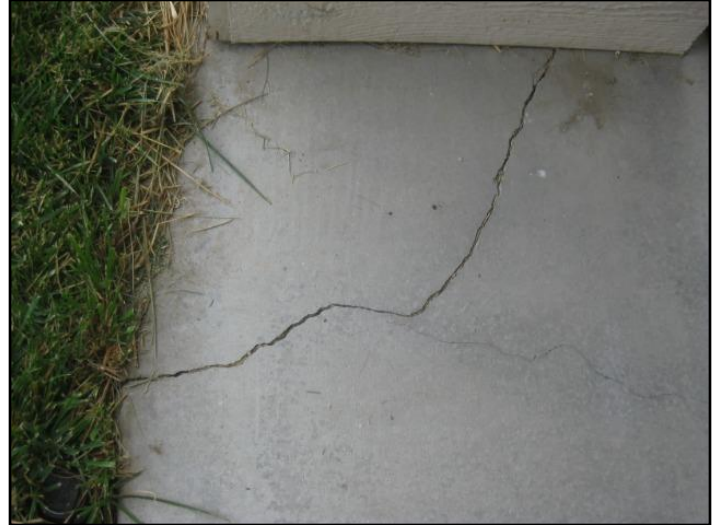
Some minor concrete was damaged. Recommend closely monitor. Repair should be relatively simple to fill/seal these

typical cracks.

14. Typical cracking

15. Typical cracking

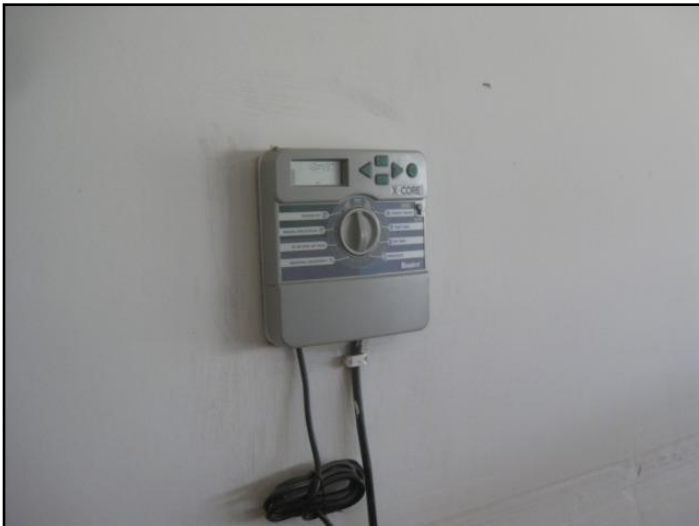
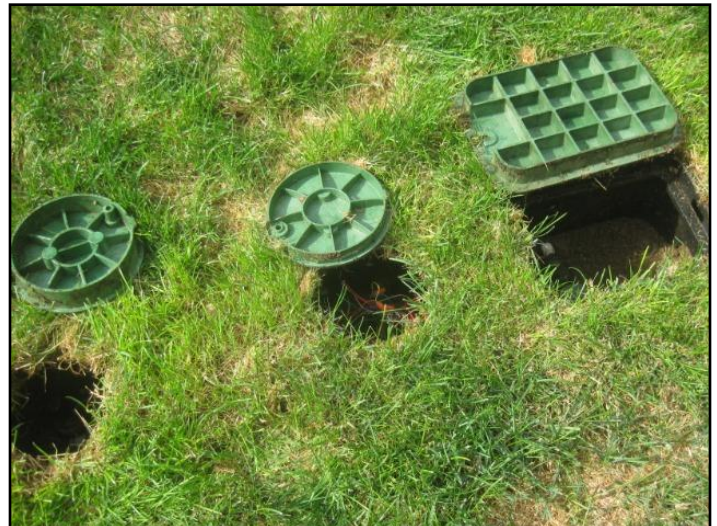
The irrigation system was not tested or seen in operation. Recommend an irrigation technician further assess the system for repair or improvement. Servicing of the system should be conducted in the fall and spring for adequate operation.

16. Timer

17. Hatches

Task: Service annually

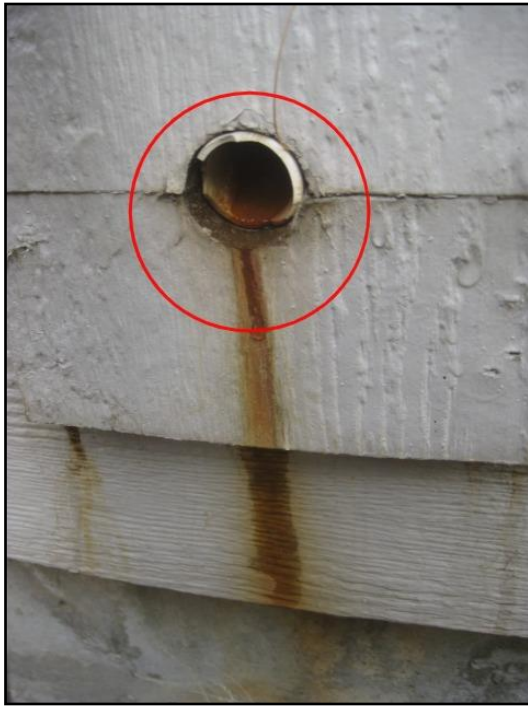
23. Broken drain pipe

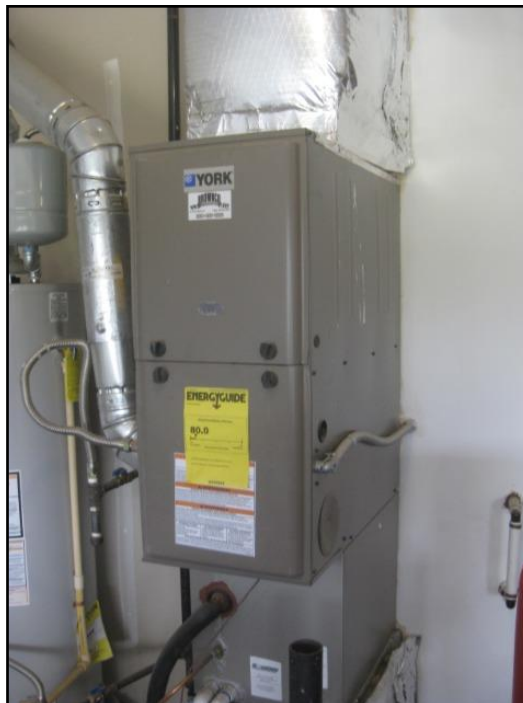
The furnace appeared to operate normally with no obvious or readily observable significant defects. The unit did not have any indication it has been serviced. These units should be serviced annually. It is recommended to have the unit serviced by a qualified HVAC technician to verify any improvements the system might require in the near future and specific servicing requirements for this model.

25. Service Furnace

Task: Service Service annually

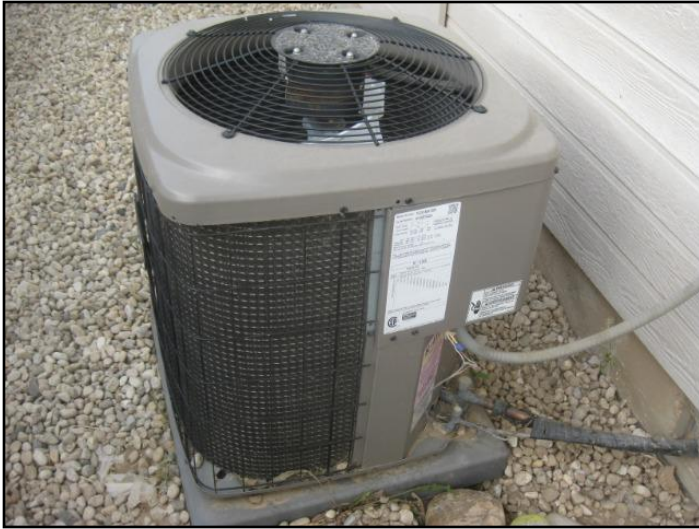
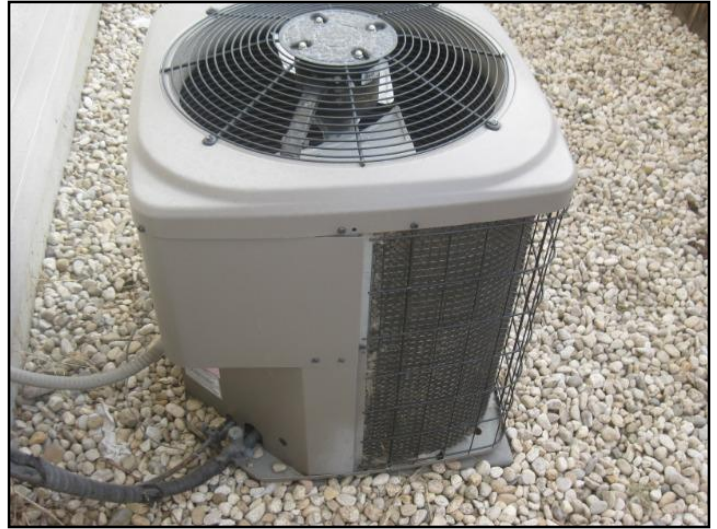
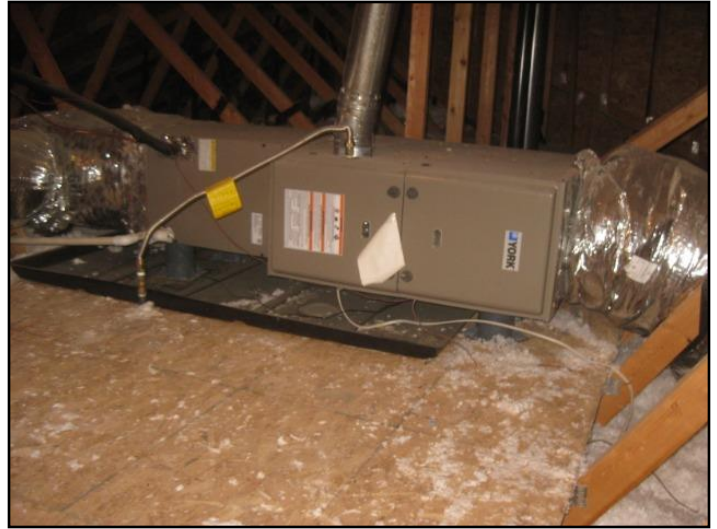
The AC appeared to be original to the structure but in functional condition at the time of the inspection. The filters were very dirty indicating the system has not undergone a service in some time. The base of the furnace was bleeding cold air when tested. There was no indication on the units the system has undergone any recent service. Recommend a HVAC technician assess the unit as soon as possible and conduct annual servicing of the system to ensure/verify proper and systemic operation.

27. Service air conditioner

28. Service air conditioner

32. Service air conditioner

Task: Service Service annually

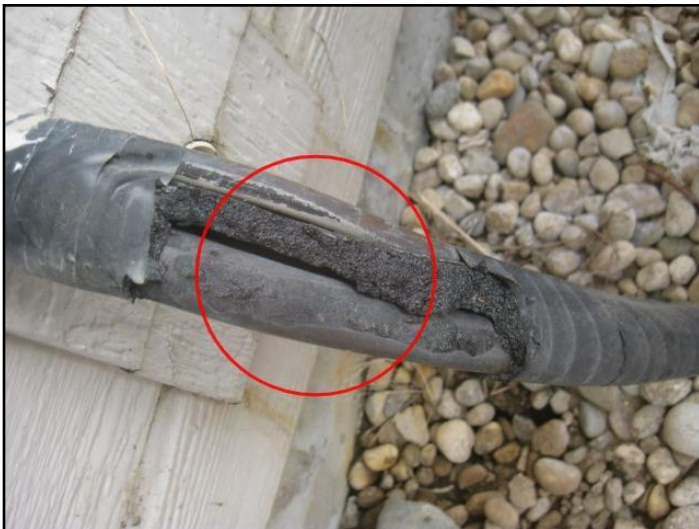
29. Missing insulation

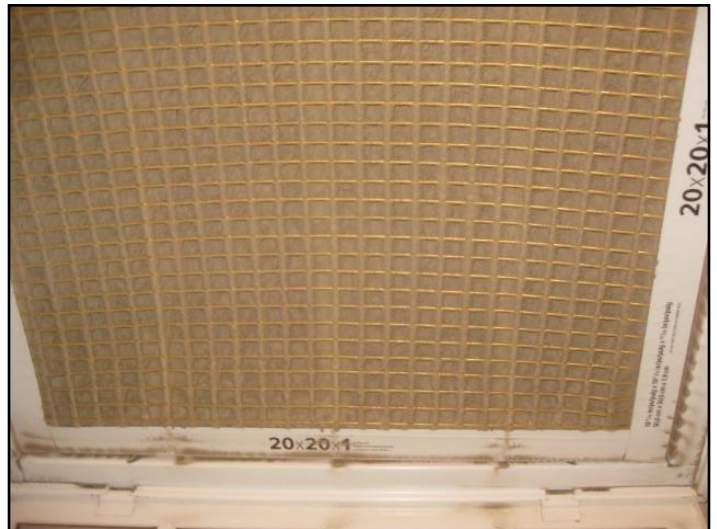
30. Dirty filter

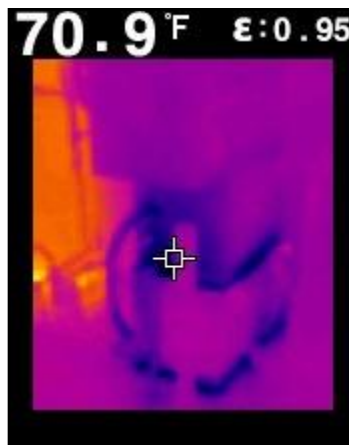
33. Cold air bleed at furnace

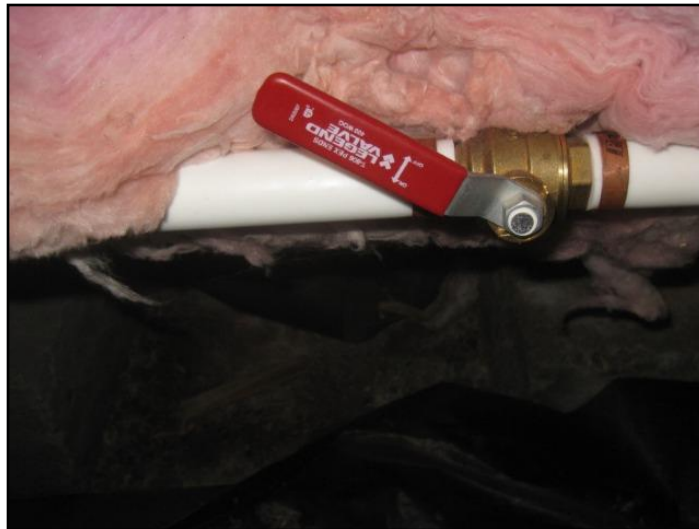
The main water shut off, located at the crawl space hatch, could not be turned off using moderate force. The main water shut off should be easy to access and easy to operate. Recommend a plumber further assess this valve for repair or replacement.

41. Inoperable

Task: Further evaluation Improve

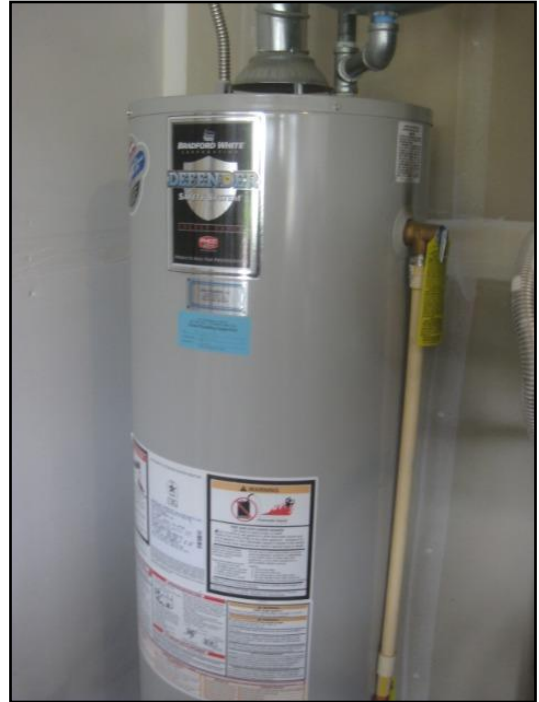
The water heater appeared and tested to be in working condition. However, there was no indication the unit had been recently serviced. Inspector heard some unusual noises coming from the water heater which indicates a possible issue with the unit. Recommend a qualified plumber assess and service the water heater.

43. Service water heater

Recommend add moisture alarms below or near all sinks and water using appliances as a preventative measure.

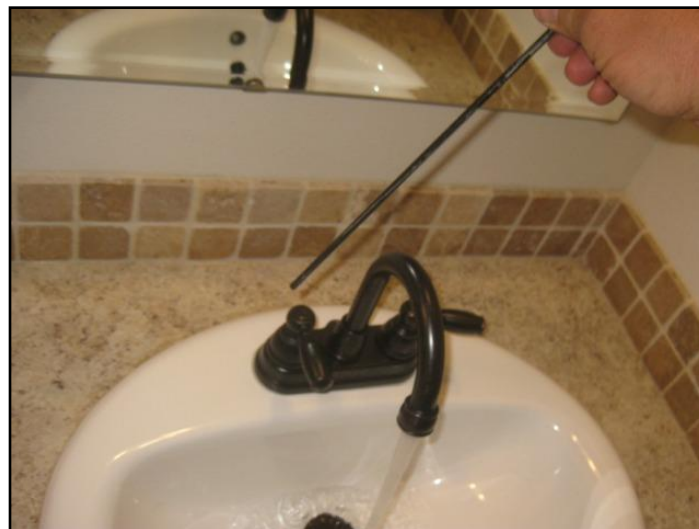
Condition: • Drain stop ineffective

Location: Master Bathroom, right side sink

44. Drain stop ineffective

Task: Repair

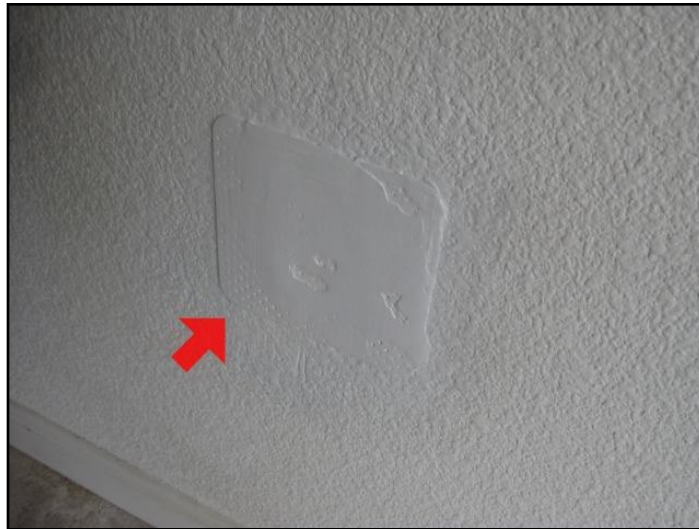
Condition: • [Patched](#)

Location: Kitchen

51. Patched

Task: Monitor

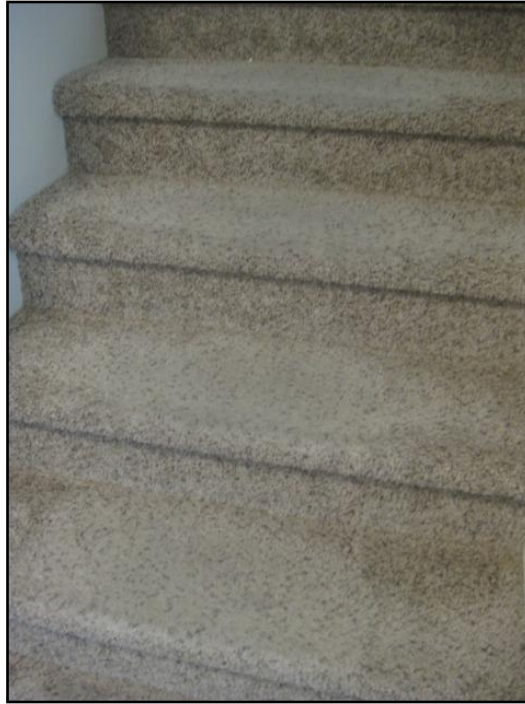
There was wear on the carpets in the high traffic areas.

52. Wear

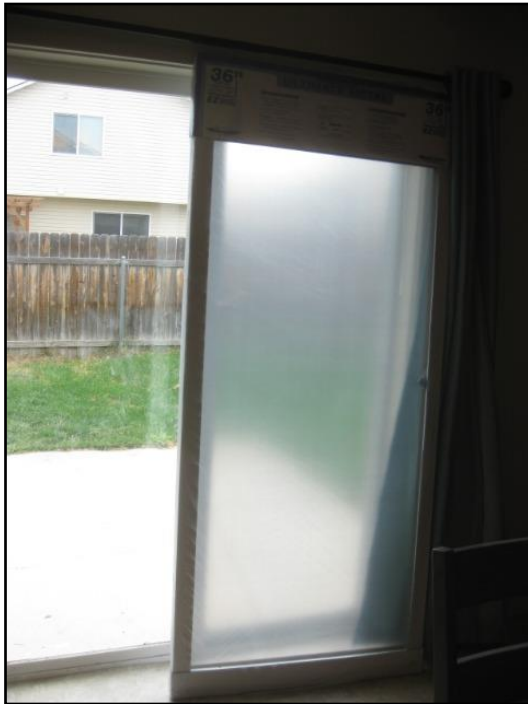
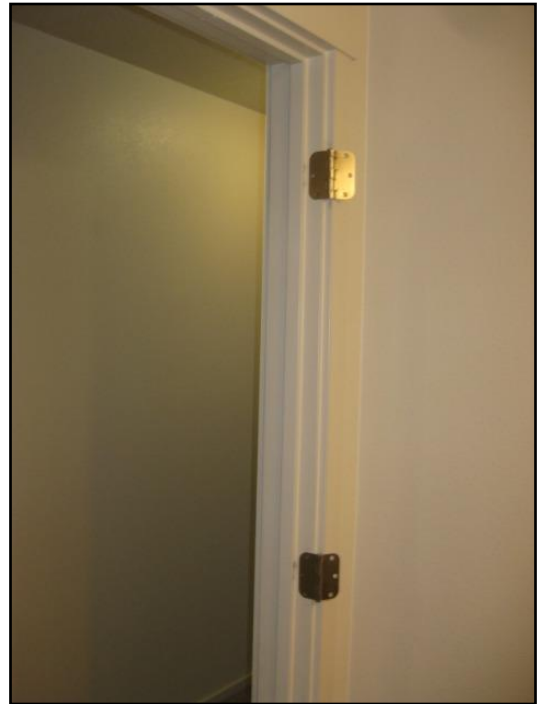
The rear kitchen screen door and second floor guest bathroom was missing/not installed. Recommend repair these doors.

53. Loose screen door

54. Missing door

Task: Repair Further evaluation Improve

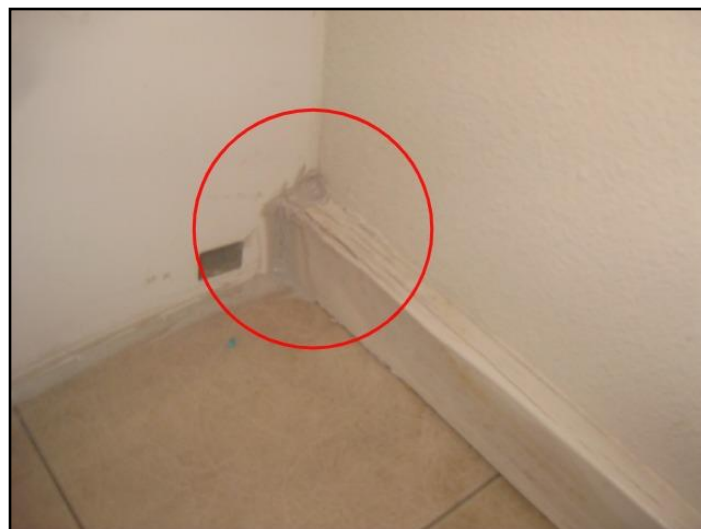
The second floor guest bathroom trim on either side of the tub had moderate water damage to the trim.

55. Water damage

Task: Improve Monitor
